## Exhibit Summary

### **Dairy Facility:** Faria Dairy, DP-923

### **Dairy Facility:** Carter's Milk Factory, DP-926

### **Dairy Facility:** Ridgecrest Dairy, DP-1346

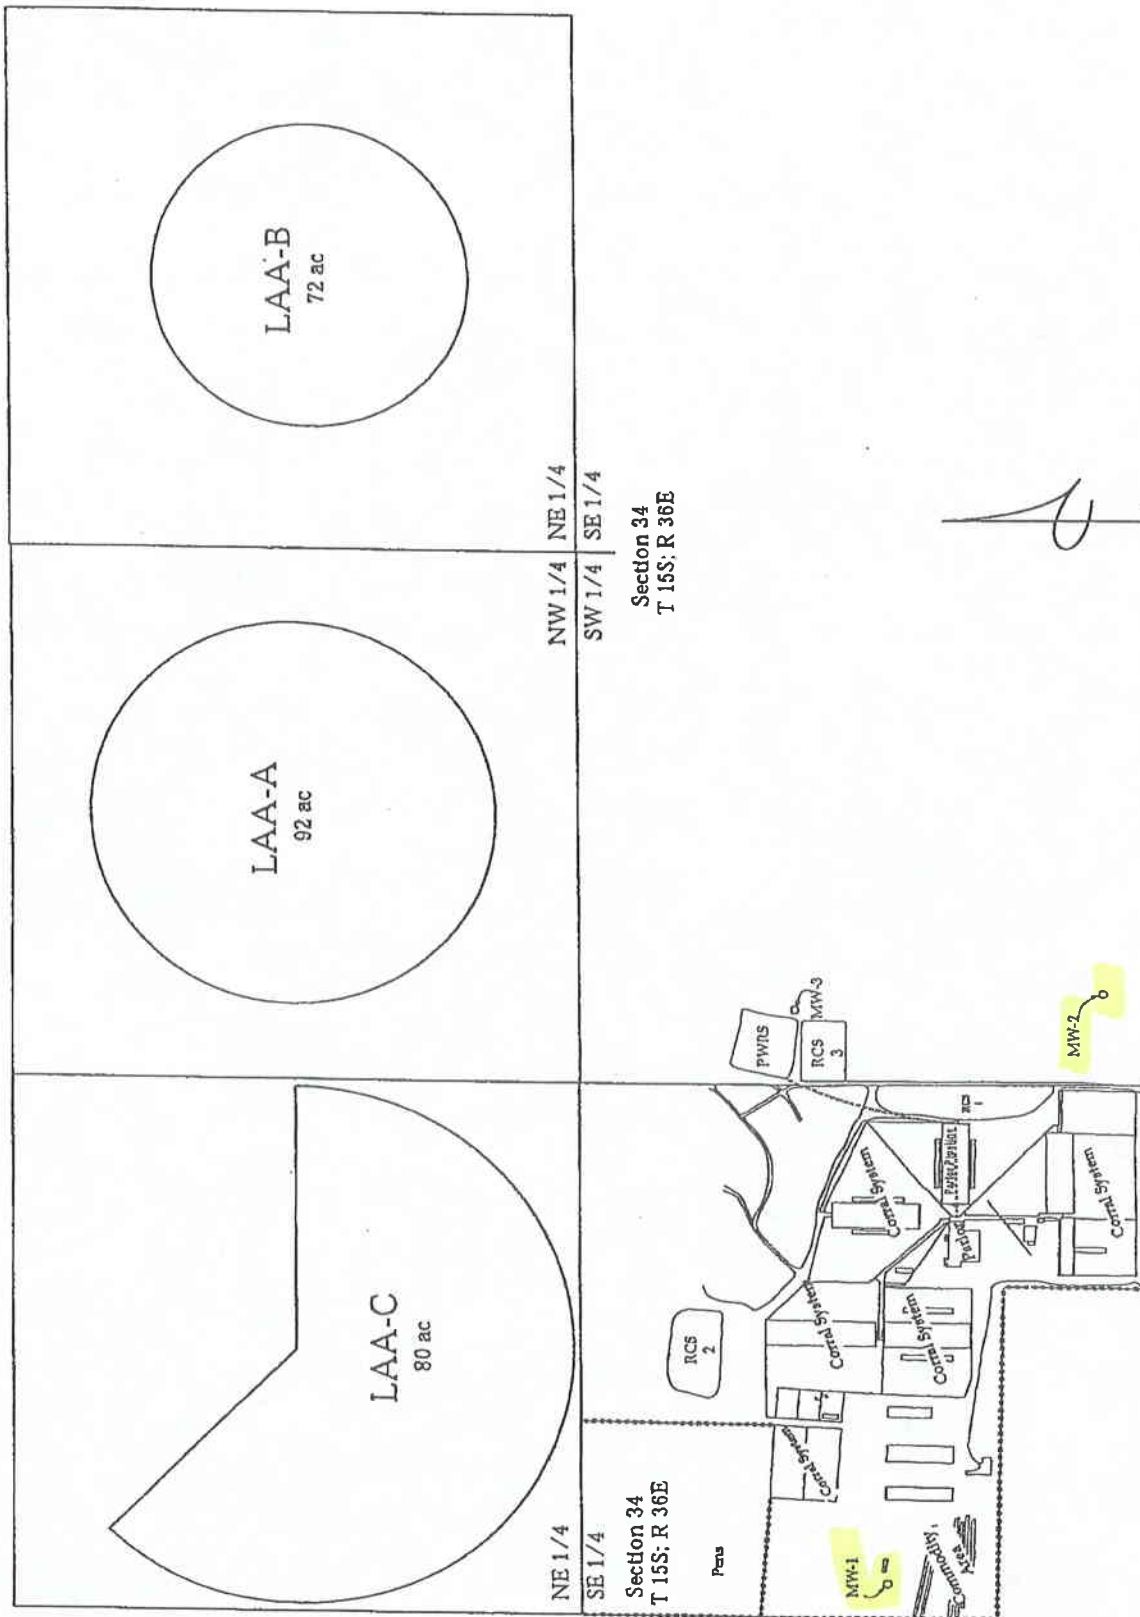
Title:	Farla East Dairy	DP-923	Sheet No
	Overall Site Layout		1/1
Date:	11/12/2004	DWG/Doc Ref	Scale 1" = 1000'

On the maps dated 11/12/2004 and 10/16/2006, monitoring well MW-2 is intended to be located hydrologically downgradient of a stormwater impoundment and monitoring well MW-1 is intended to be located hydrologically upgradient of the facility. The map dated 10/08/2008 has the wells reversed such that MW-1 is intended to be located hydrologically downgradient of a stormwater impoundment and MW-2 is intended to be located hydrologically upgradient of the facility.

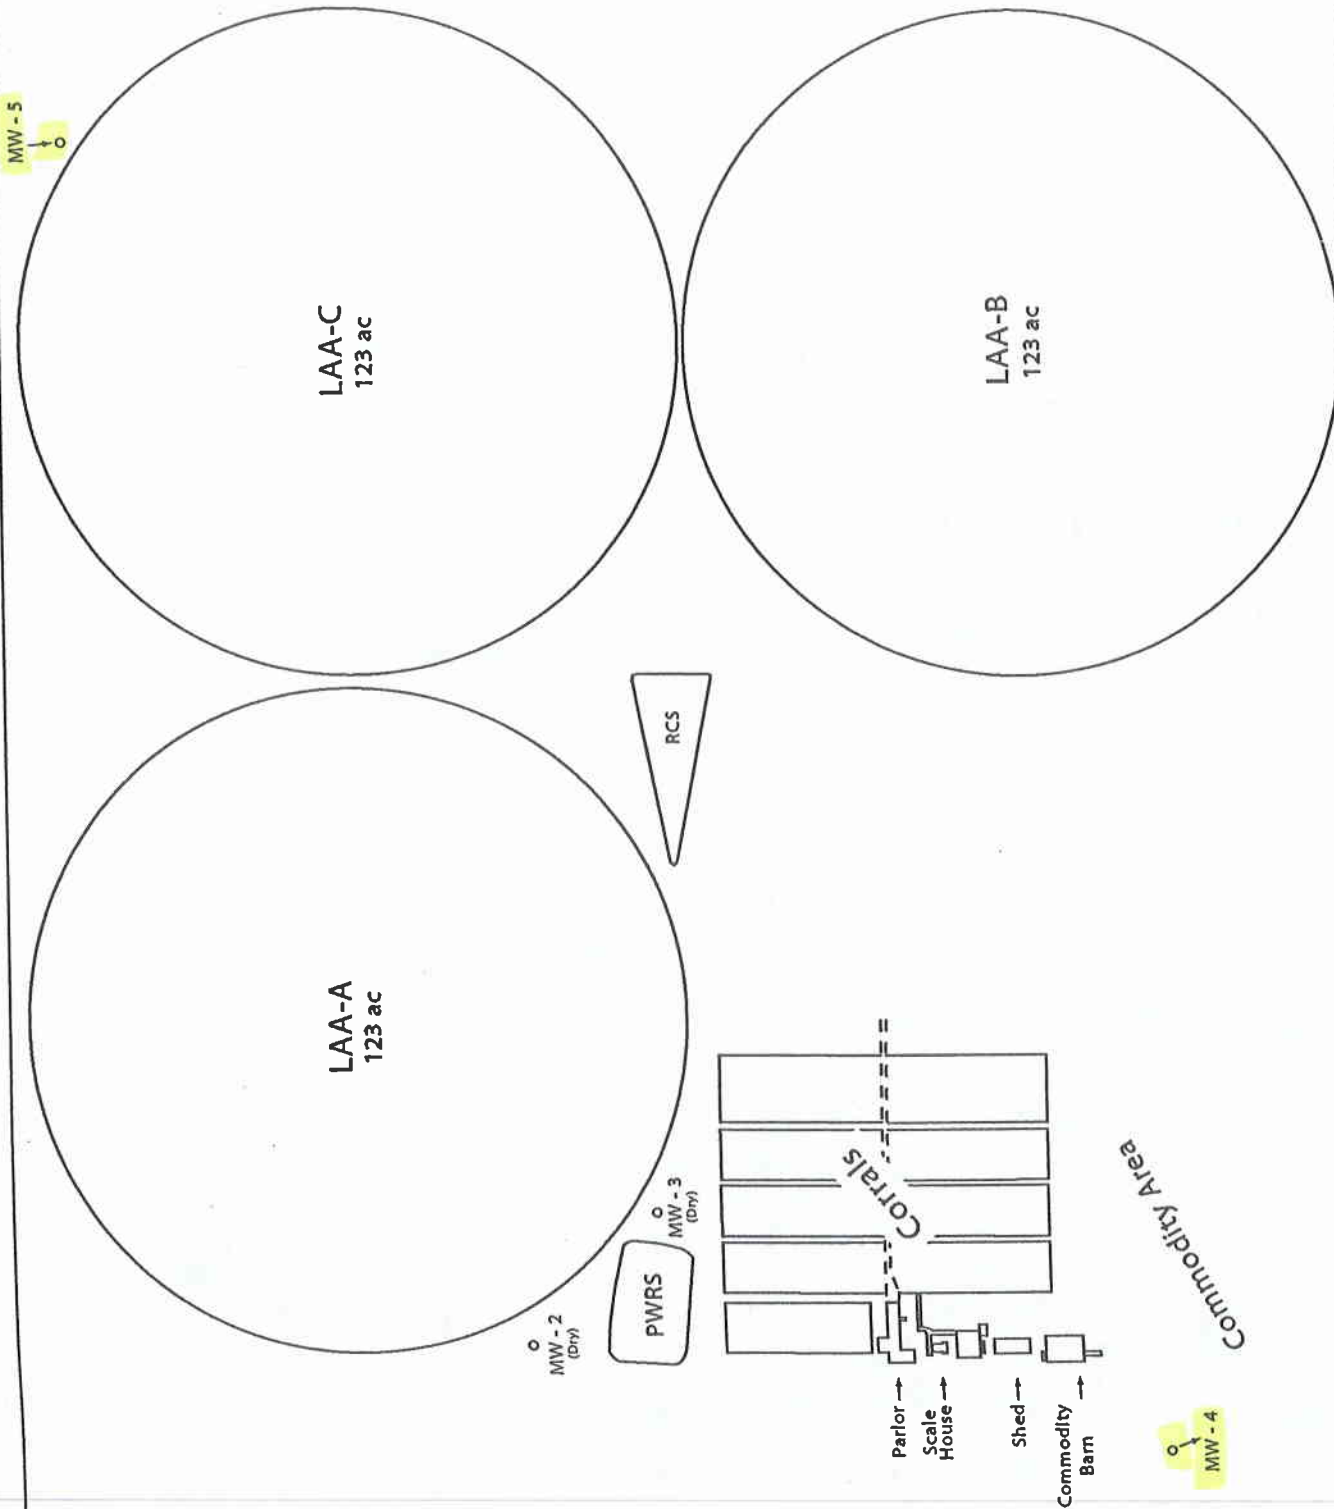
Title:	Carter's Milk Factory Overall Site Layout	DP-926
Date:	5/22/2003	Sheet No 1/1
	DWG/Doc Ref

On the map dated 05/22/2003, monitoring well MW-5 is intended to be located hydrologically downgradient of the land application area and monitoring well MW-4 is intended to be located hydrologically upgradient of the facility. The map dated 06/09/2004 has the wells reversed such that MW-4 is intended to be located hydrologically downgradient of the land application area and MW-5 is intended to be located hydrologically upgradient of the facility.

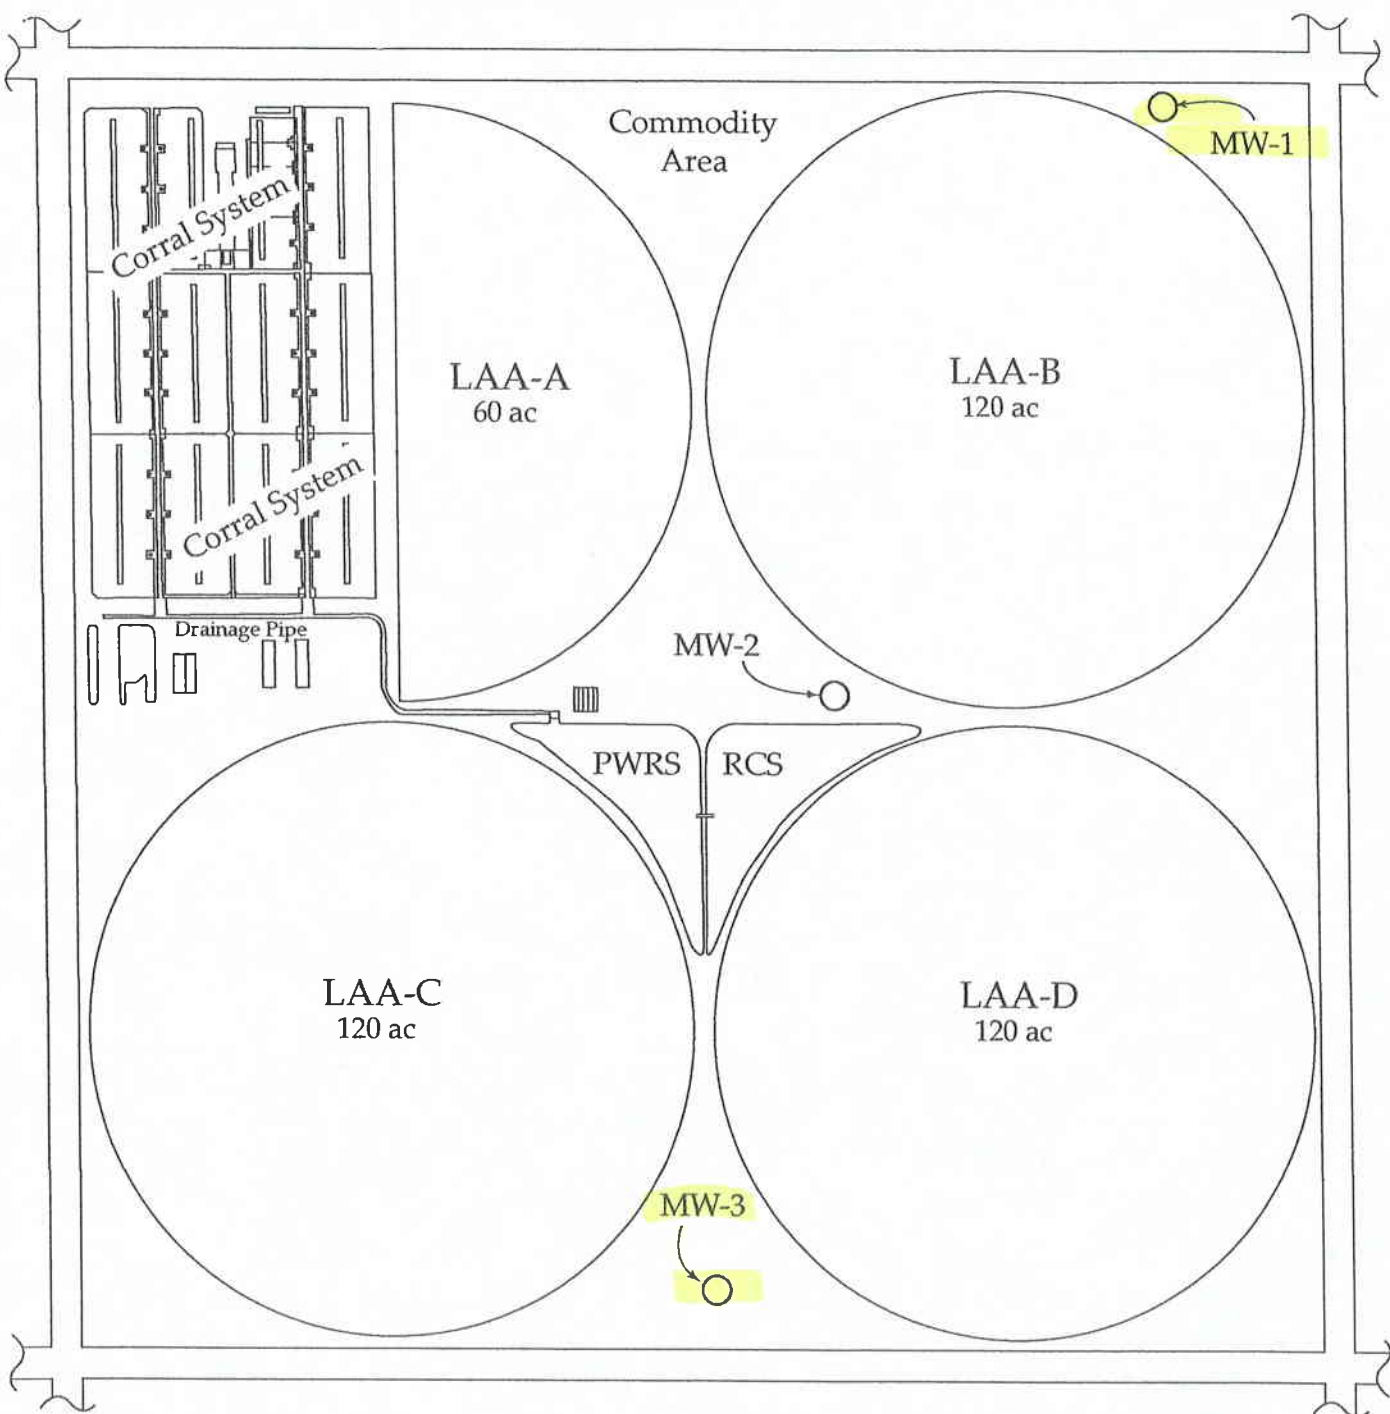
Title: Ridgecrest Dairy Overall Site Layout		DP-1346
Date: 9/1/2004	DWG/Doc Ref Scale 1"=800'	Sheet No 1/1

On the map dated 09/01/2004, monitoring well MW-1 is intended to be located hydrologically downgradient of the land application area and monitoring well MW-3 is intended to be located hydrologically upgradient of the facility. The map dated 02/19/2009 has the wells reversed such that MW-3 is intended to be located hydrologically downgradient of the land application area and MW-1 is intended to be located hydrologically upgradient of the facility.

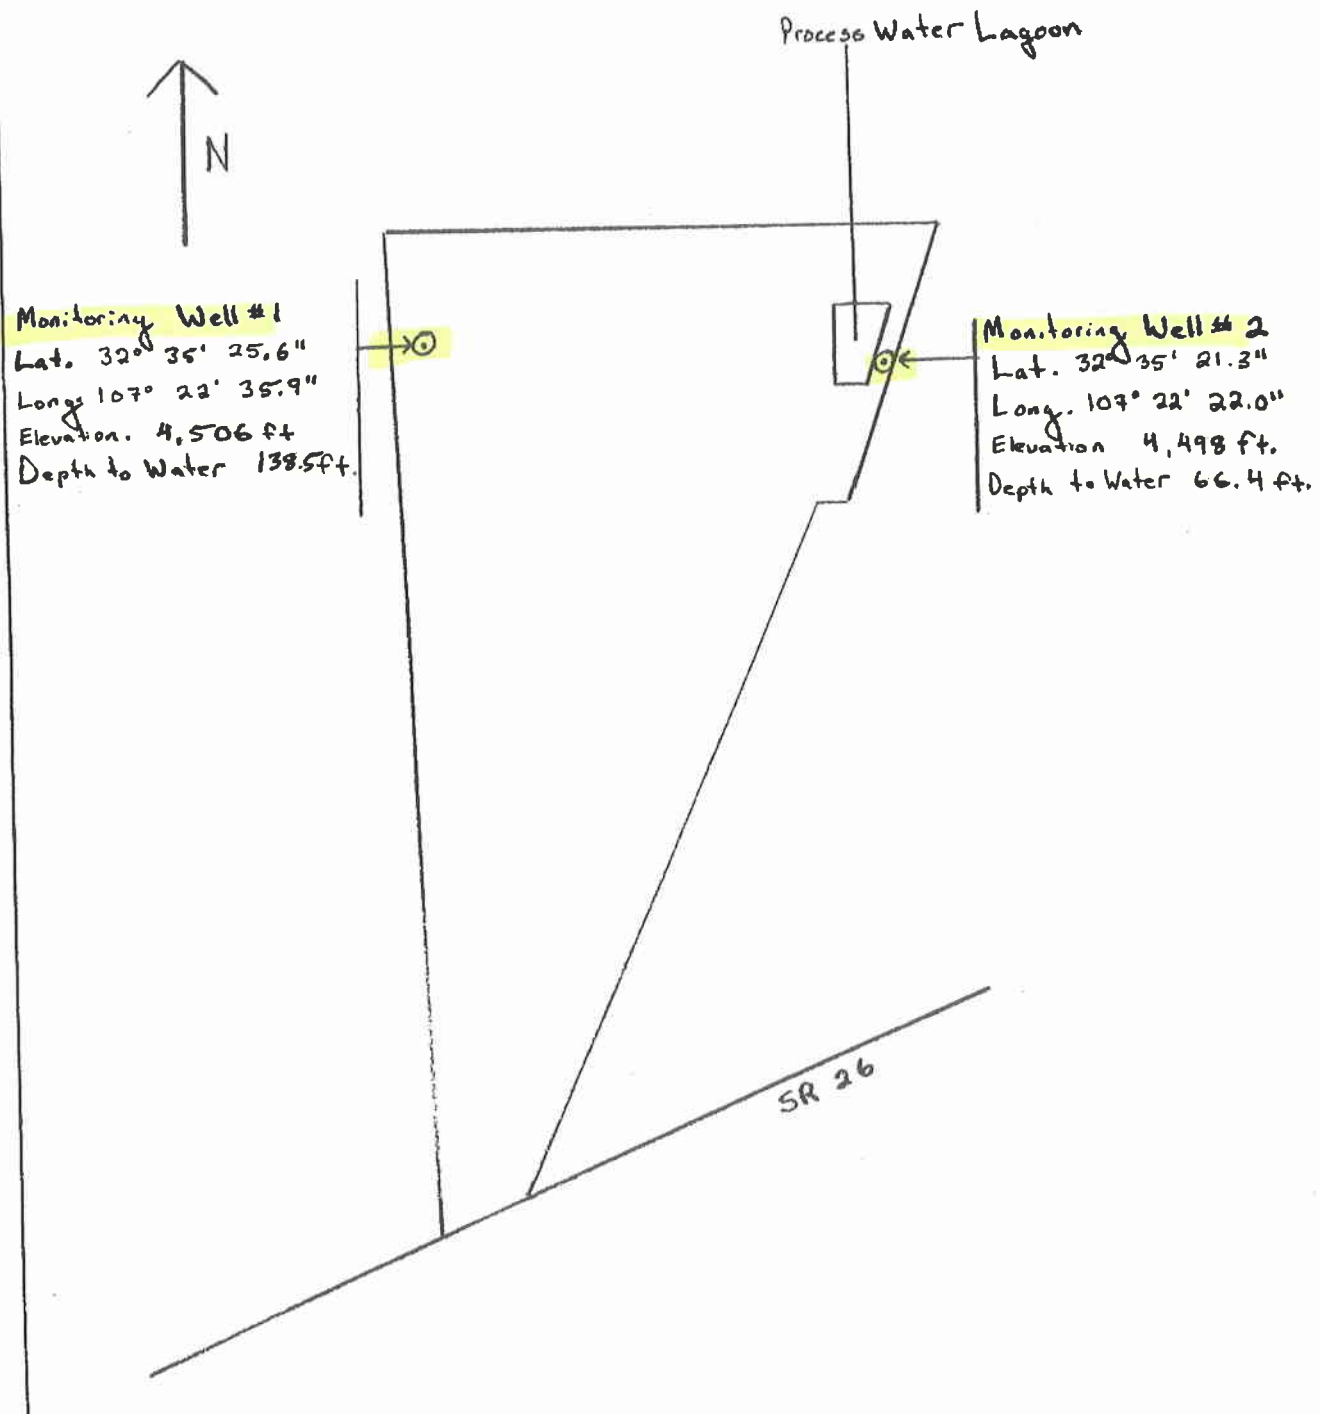
Submitted ~ 2003

On the map submitted in 2003, monitoring well MW-2 is intended to be located hydrologically downgradient of the wastewater impoundment and monitoring well MW-1 is intended to be located hydrologically upgradient of the facility. The maps submitted in 2005 and 2009 have the wells reversed such that MW-1 is intended to be located hydrologically downgradient of the wastewater impoundment and MW-2 is intended to be located hydrologically upgradient of the facility.
